Revegetation at Crater Lake National Park:  
A Survey of Historic and Active “Orphaned” Sites.

Susie Roe Andersen  
Biological Science Technician – Botany  
Crater Lake National Park  
September 26, 2008

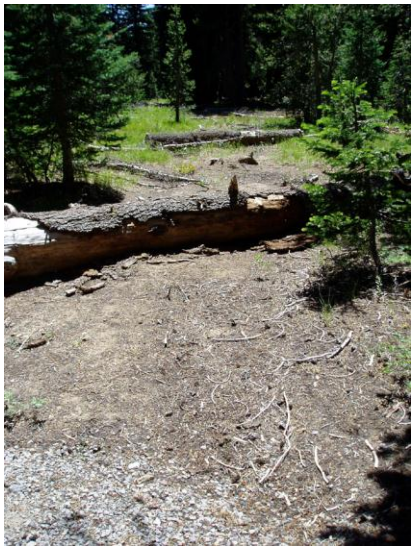
**Restoration Success/Failure:** This project had approximately 30% success. The Social Road (Fig.2) and revegetated picnic table area (Fig.3) are still clearly visible with mostly barren soil and sparse vegetation compared to the meadow it runs through. The jute erosion matting is wadded up on the sides caught by downed logs, and the green “photodegradeable” plastic matting is clearly visible and does not appear to be degrading after 10 years (Fig. 6). Only two of the transplanted *Tsuga mertensiana* seedlings survive along with sparse grasses, sedges and forbs (Fig. 4,5)

Fig. 4 - Vidae falls social road revegetated.

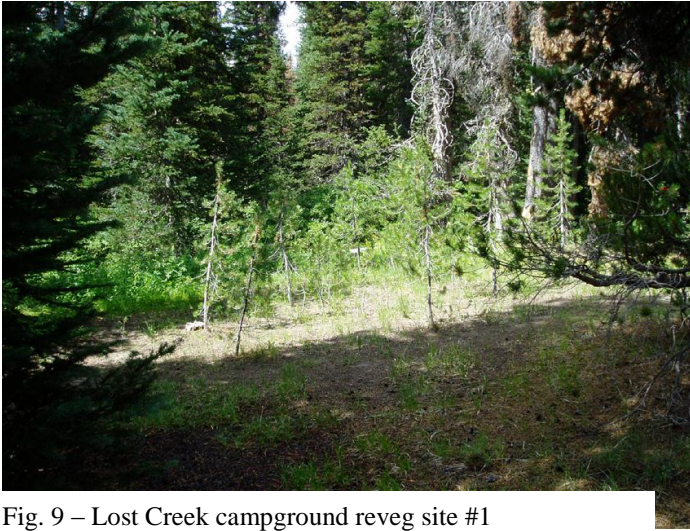
#### Site #1 (Fig. 9)

Fig. 9 – Lost Creek campground reveg site #1

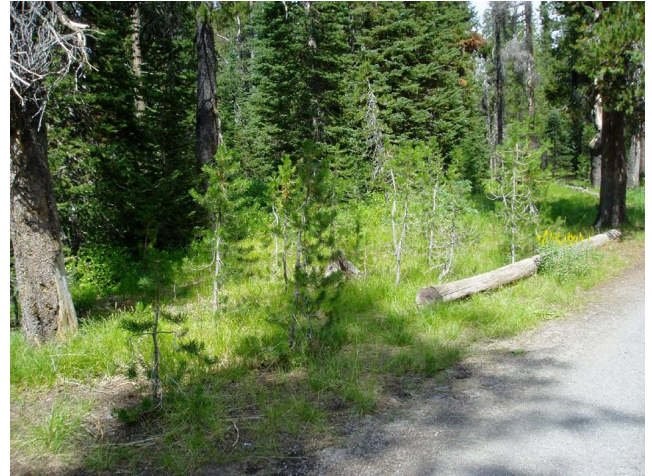
Site #2 (Fig.10)

Fig.10 – Lost Creek campground reveg site #2

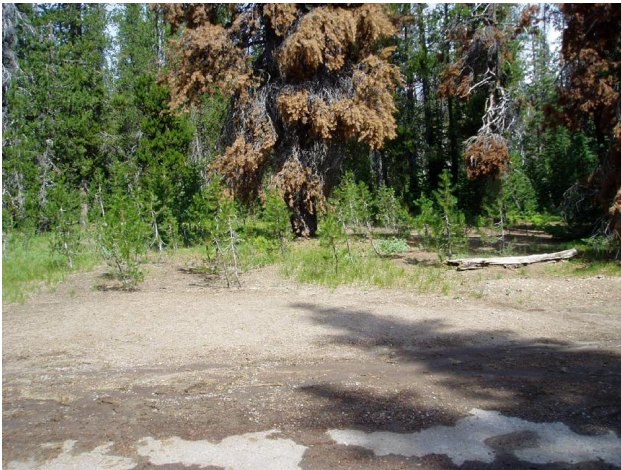
Site #3 (Fig.11)

Fig.11 – Lost Creek campground reveg site #3

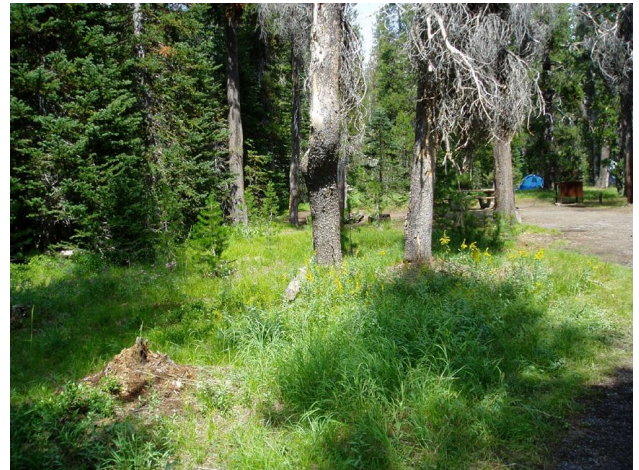
Site #4 (Fig.12)

Fig. 12 – Lost Creek campground reveg. site #4

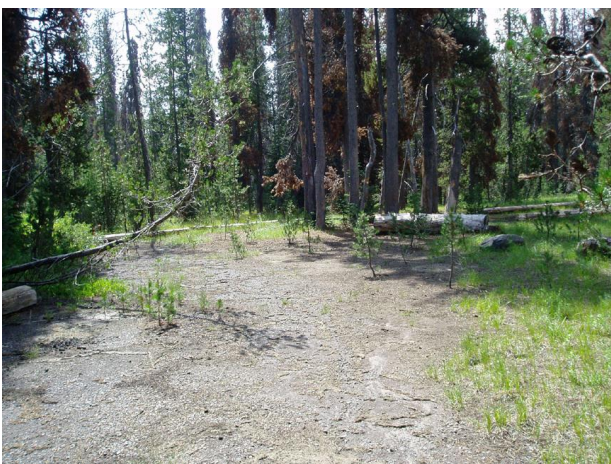
Site #5 (Fig.13)

Fig. 13 – Lost Creek campground reveg sites#5 and #6.

Site #6 is in greatest need of restoration due to the erosional run off into Lost Creek and the lack of vegetation throughout the site. Sites #7 and 8 should also be restored.

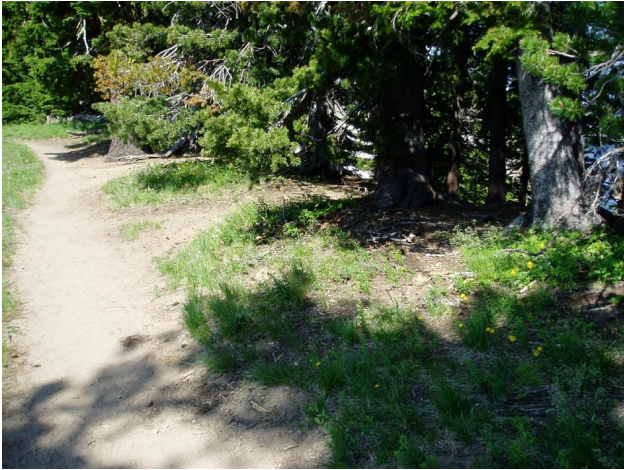
The success rate is 10% along the rim. Some of the social trails are no longer used because of blockage by downed logs, however numerous new and existing trails wind in and out of the area (Fig. 19). There is no evidence of the “hitching post” style barriers. The vegetation is denuded and social trails continue to the west toward Applegate peak (Fig. 22) and east toward Dutton peak (Fig. 23). A significant social trail goes down 20 feet into the caldera to a precipitous viewpoint of Phantom Ship (Fig. 20).

Fig. 19 – Sun Notch social trail network at caldera rim.

**Recommendations:** A new plan for flow of foot traffic at Sun Notch is vital because visitors will continue to look for the shortest distance to the rim as possible. Social trails through the meadow and at the rim should be revegetated with on-site native seeds, with the exception of Crater Lake current *Ribes erythrocarpum* which is a host for the whitebark pine blister rust fungus (see Rim Village cafeteria/whitebark pine restoration). Log barriers should also be placed to direct traffic flow. Interpretive signage should be placed to educate visitors about the delicate sub-alpine meadow ecosystem and encourage responsible hiking. During spring melt-out the trail should be marked so that social trails don’t develop when visitors cannot locate the main trail. Species recommended for seeding are as follows:

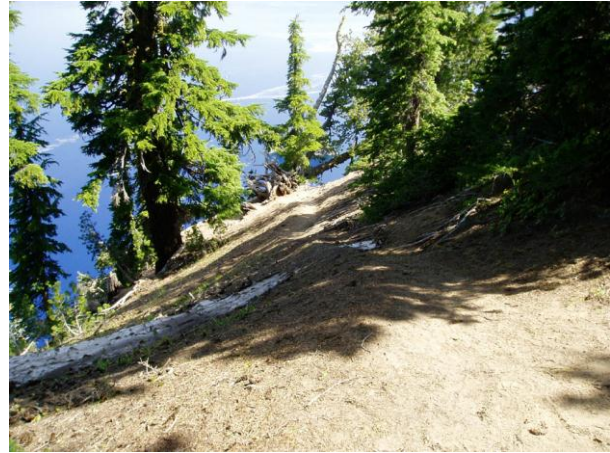
Fig. 20 – Sun Notch social trail heads down into caldera to view Phantom Ship.

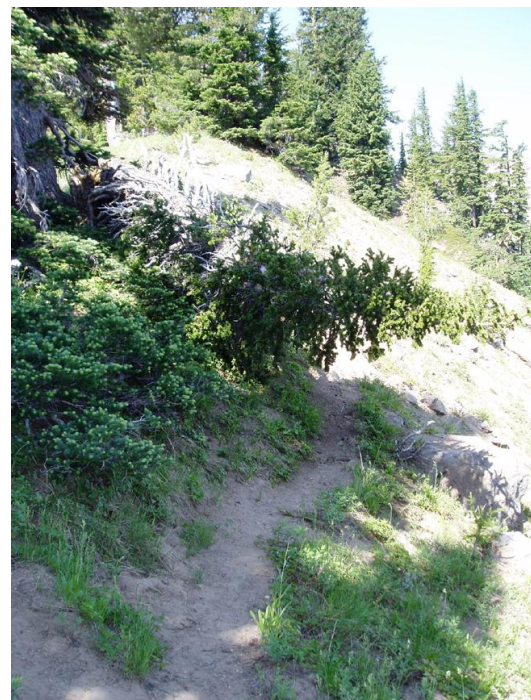
Fig. 22 – Sun Notch social trail continues toward Applegate Peak.

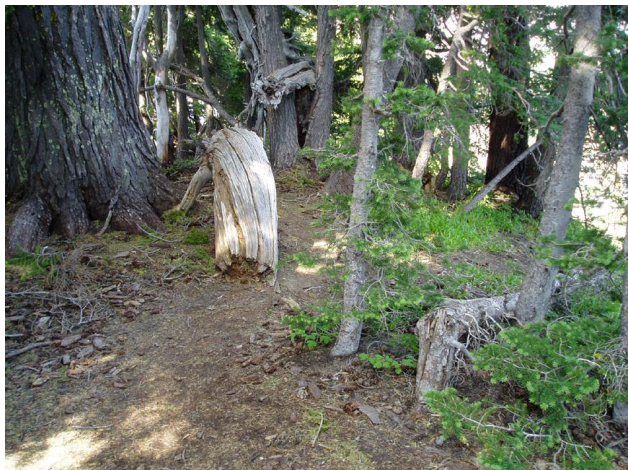
**Current Conditions:** The area has a network of social trails. The first social trail begins about 20 feet from the trailhead and goes to the left around a group of mountain hemlock (Fig. 25). The official trail is excessively wide in many places and has sections with significant erosion over exposed tree roots. The remains of small social trails go through the center of the meadow (Fig. 24). Another eroded social trail leads to the right off of the main trail and is so wide it looks like an official trail (Fig. 26). A network of social trails winds in and out of the forested rim area (Fig. 19), down into the caldera (Fig. 20), towards the west to Applegate Peak (Fig. 22) and the east to Dutton Ridge (Fig. 23). Wide areas of trampling have denuded the vegetation to bare soil (Fig. 21).

Fig. 23 – Sun Notch social trail continues toward Dutton Peak.

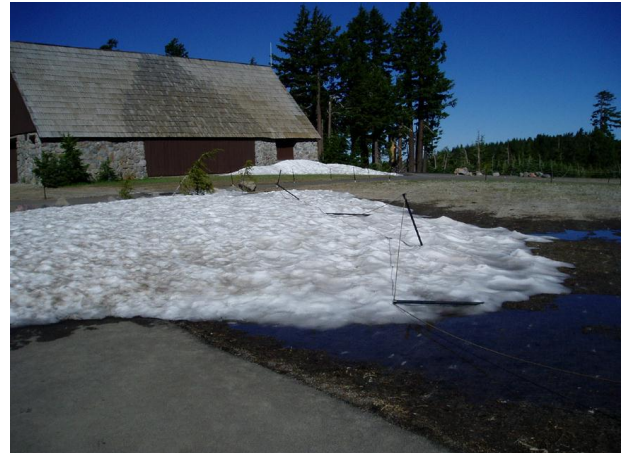
Fig. 28 – Rim Village reveg attempt to protect landscape during snowmelt.

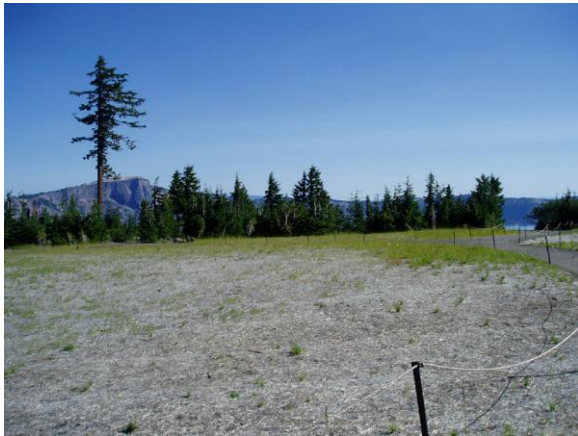
To water the landscape a hose must be connected to the restrooms across a busy lane of traffic and laid across the roadway (Fig. 37). Again, many hours of staff time are required to move hoses and sprinklers across the landscape. Some areas had 100% mortality and are barren of any vegetation (Fig. 32, 35). All that remains in these areas are pieces of torn erosion matting (Fig. 35). Some areas have had moderate success, especially the plantings closer to rim and behind the cafeteria (Fig 31, 34). This success is due in part to more fertile soils in the original landscape islands closer to the rim and less foot traffic behind the cafeteria. The upland islands are over the former parking lot where the soils are shallow and infertile, making growth very difficult (Fig. 29, 30).

Fig. 29 – Rim Village reveg in front of 1928 Building looking toward Crater Lake.

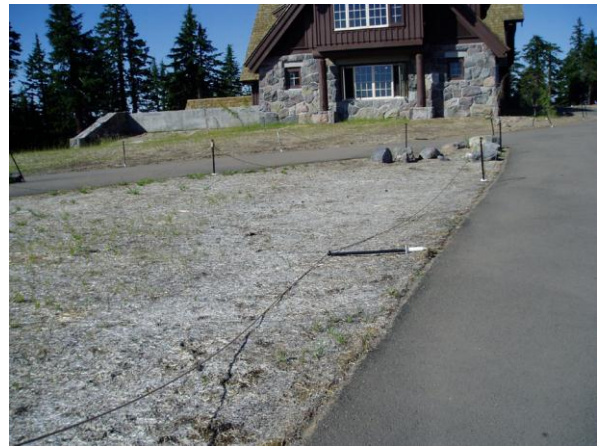
Fig. 30 – Rim Village reveg in front of Cafeteria.

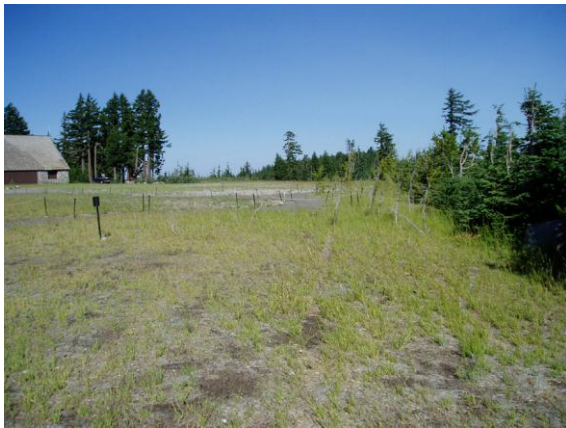
Fig. 31 – Rim Village revegetation greater success of grasses and forbs closer to lake and higher fertility soils. High mortality of transplanted Mt. Hemlock.

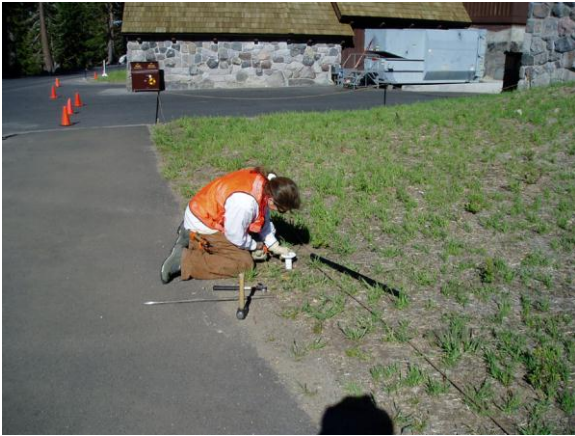
Fig. 33 – Rim Village reveg installing pole sockets to hold poles.

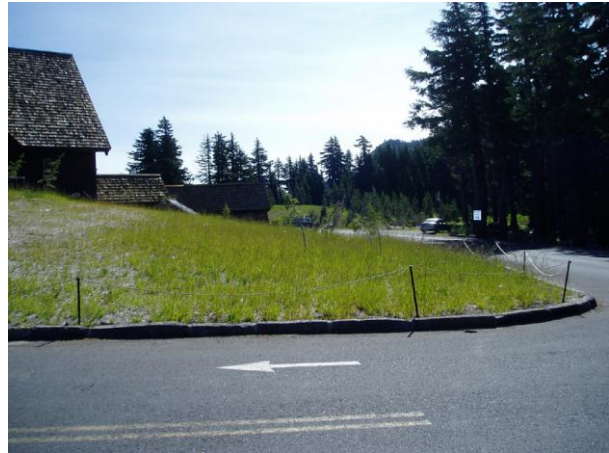
Fig. 34 – Rim Village revegetation behind cafeteria is doing better.

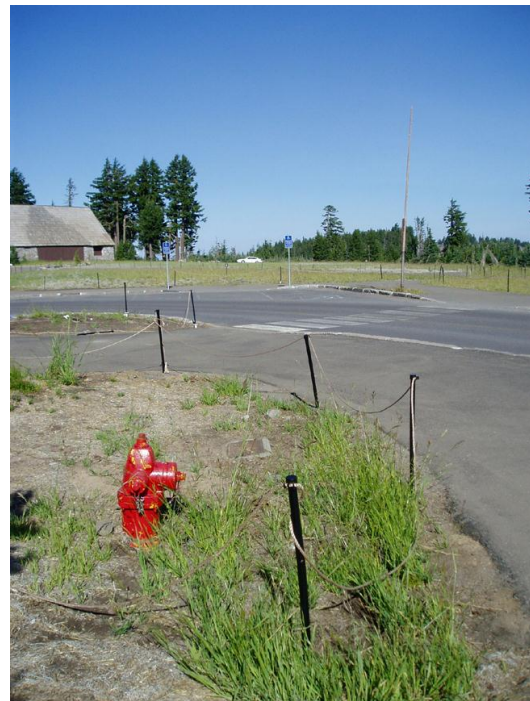
Fig. 37 - Rim Village reveg access to water across the street from landscape islands.

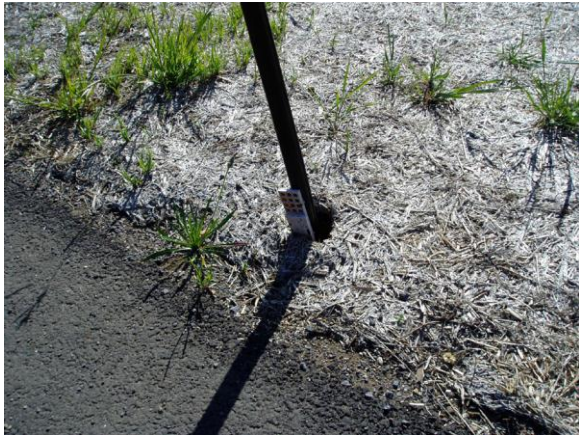
**Restoration Successes/Failures:** The original design of the landscaping at this site included topography, an in-ground watering system, and fencing/physical barriers to match the National Park Service rustic architecture at the site. These three items were subsequently cut from the final landscape design leaving the plantings subject to heavy foot traffic and short-cutting by visitors. To alleviate the trampling, a temporary plastic fence with roping was approved and installed (Fig. 33, 39), however the soils are so hard it is very difficult to keep the poles upright (Fig. 36) and many hours of staff time are involved in maintaining the fencing. Various techniques have been employed to strengthen the poles such as wood shims and pole sockets with little success (Fig. 33,36,38,39). During snowmelt it is especially challenging to install the poles adequately to protect the landscape because visitors do not want to walk over snow and because the poles fall quickly as snow recedes (Fig. 27, 28). On August 15, 2008 rebar was installed and the plastic poles were slid over the top. This gave more strength and stability to the poles and improved the fence barrier.

Fig. 38 – Rim Village reveg wood shims used to prop up poles.

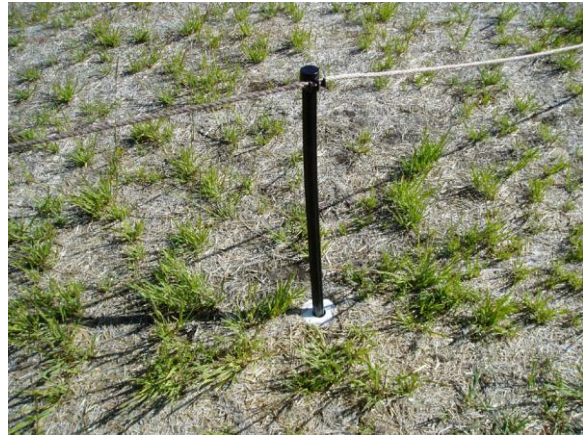
Fig. 39 – Rim Village reveg pole sockets successful in better soils.

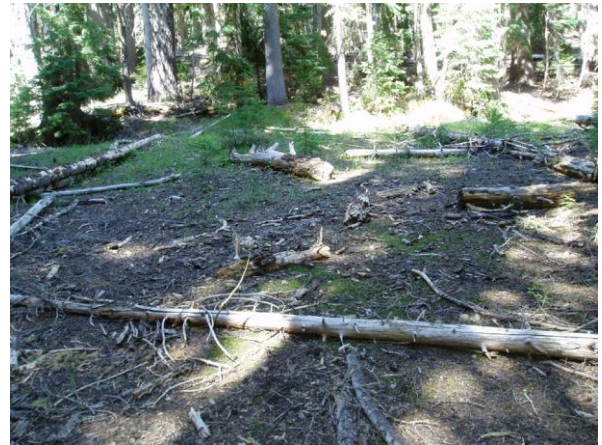
In 1997 the hiking trail was re-routed off of the historic road and the hitching rail was relocated. A restoration project was initiated in the fall of 1998 and spring of 1999 to restore the population of *C. mazama* that had been damaged by hiker and pack animal trampling (Fig. 41). Seeds were collected from Sphagnum Bog and Copeland Creek populations and propagated at the University of Idaho Forest Nursery Greenhouse. 500 seeds were stratified and divided into equal groups. Half were scarified with sandpaper while half were not scarified. Seeds were then germinated and grown in the nursery. Genetic studies were conducted and four parent plants were selected with the highest heterozygosity for vegetative cloning. In fall of 1998, 166 seedlings and 400 vegetative clones were planted. In spring of 1999, 442 seedlings and 200 vegetative clones were planted. Seedlings were backpacked into the site by a graduate researcher, park staff, and volunteers from the Friends of Crater Lake National Park. A total of 14 randomly selected plots were planted (Fig. 47). Holes were dug to a depth of approximately 15 cm using bulb planters, the plant roots were then loosened and the plants were placed into holes and the roots were covered with soil (Baldwin and Brunsfeld, 2001). The plants were then watered with a hand pump. In spring of 2000 a survivorship survey was conducted and found 65% of seedlings and 58% of vegetative clones surviving.

Fig. 41 – Main *C. mazama* population south of old road bed.

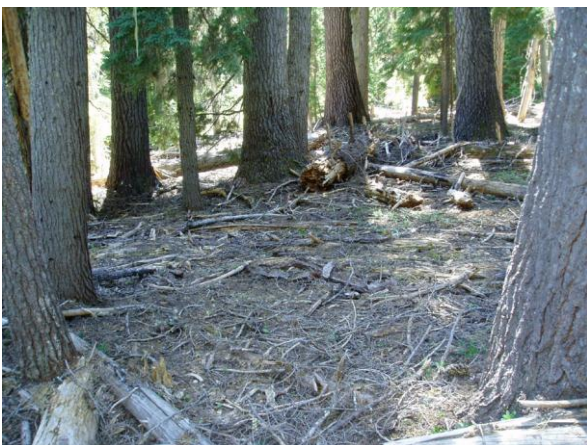
**Site Description:** The *Collomia mazama* (Fig. 42) population at Sphagnum Bog was severely impacted by historic road construction and by trampling from pack animals tied to a hitching rail located adjacent to the site. (Baldwin and Brunsfeld, 2001). The site is located at an elevation of 5200' with a moderate slope dominated by a dense overstory of *Abies x shastensis* (Shasta red fir) and a sparse understory of scattered *Carex* sp., *Chimaphila umbellata* (Prince's pine) and *Aster foliaceus* var *parryi* (Leafy aster). There has been significant blowdown of trees, branches and bark which now covers half of the site obscuring many of the restoration plots (Fig.44 ).

Fig. 44 – Restoration plots with tree fall.

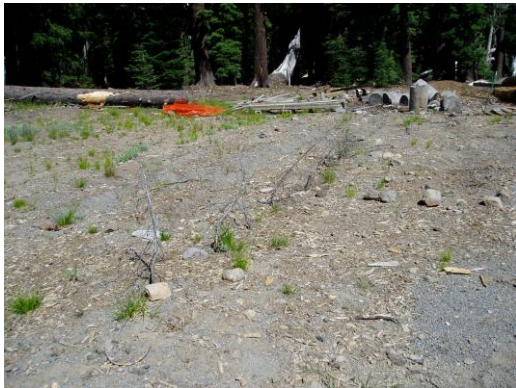
Current Conditions: This is a boneyard for large logs, boulders, gravel, asphalt, cement barriers, winter shelters, plows, flatbed truck, picnic tables, garbage/recycle bins, etc. The remains of an old shadehouse can be found in the northwest corner of the site near a water supply. Dead trees with metal tags and broken plastic pots are visible within the footprint of the former shade house. This was used for revegetation projects however nothing remains of the original metal framed shade house. No weeds were found.

Fig. 48 – Remains of old shade house.

Recommendations: This would be a great location to resurrect a shade house since it's so close to a water source and to headquarters. Since the area is still used by maintenance it does not make sense to do any revegetation at the site.

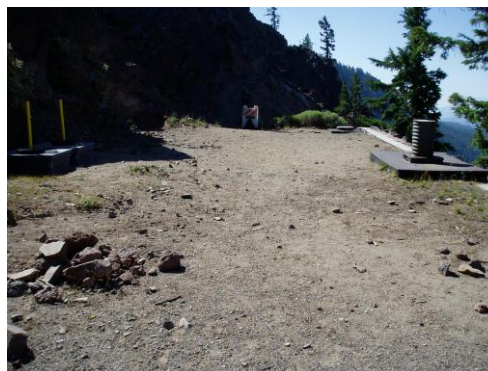
Fig. 58 – Top of water tank looking back toward do not enter sign.

Recommendations: Top of tank should be revegetated and a barrier to foot traffic installed to keep hikers off the tank.

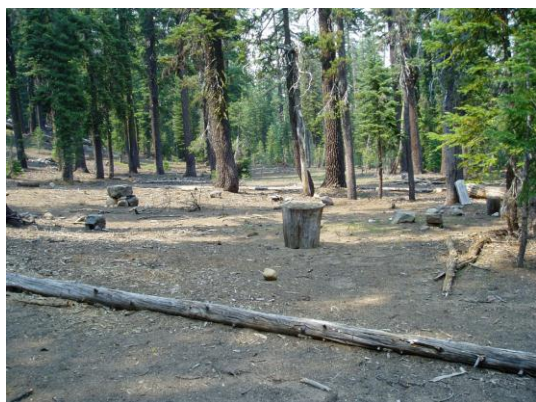
Current Conditions: Downed logs form a square area of about  $\frac{1}{4}$  acre which contains a rock "shrine" with the Mason symbol carved on the top. Stacked rock seats and a stump "pedestal" have been placed within the area. A fire pit is about 20 feet from the main shrine area with partially burned logs. Nearby trees have been cut and burned. No trash or weeds were found at the site.

Fig. 60 – Mason shrine and pedestal in meeting area.

Recommendations: The site could be restored by scattering the logs and rocks. Some revegetation could be done in the central meeting area which has been trampled over the years, however natural revegetation will probably suffice.

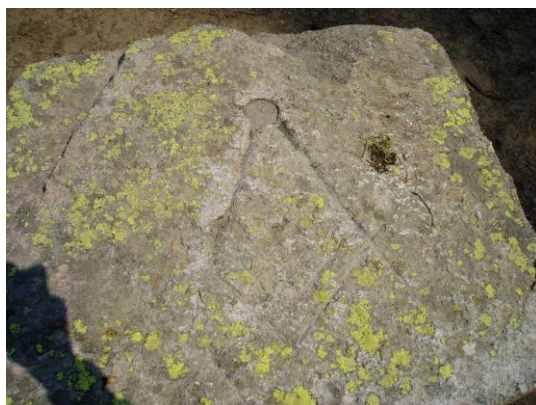
Fig. 62 – Mason symbol carved on rock shrine.

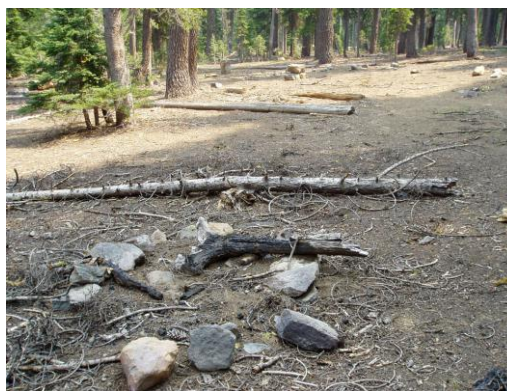
Fig. 63 – Firepit with shrine area in background.

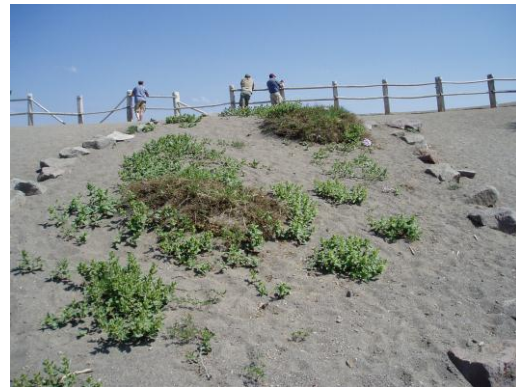
Current Conditions: Heavily impacted area with many wide social trails. A wide path (10-15' wide) leads from the parking area to a broken fence at the rim. Several social trails and trampled areas to the right and left of the main path lead into the forested rim area. A central "planter" area is also trampled and has sparse vegetation. The area beyond the fence is trampled indicating the fence does not stop foot traffic. Social trails also lead visitors to the area behind the fence to a precipitous slope. A wide social trail leads from the overlook up to another flat bench that is also trampled and devoid of vegetation. From this area another social trail continues up Llao Rock and leads visitors into a large Crater Lake Moonwort (*Botrychium pumicola*) population.

Fig 65 – Central "planter" area trampling and sparse vegetation.

Recommendations: This is one of the most critical revegetation sites in the park. It is the first overlook of Crater Lake that visitors encounter when entering the park from the north. It is also the conduit for foot traffic up Llao rock, potentially trampling the Crater Lake Moonwort (*B. pumicola*), a rare plant that is a Federally listed Species of Concern and State of Oregon listed as Threatened.

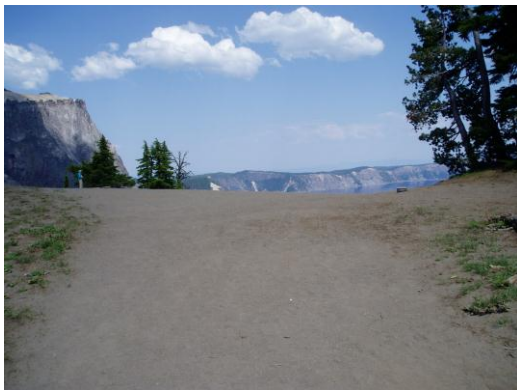
Fig. 69 – Wide social trail to view of Llaio Rock.

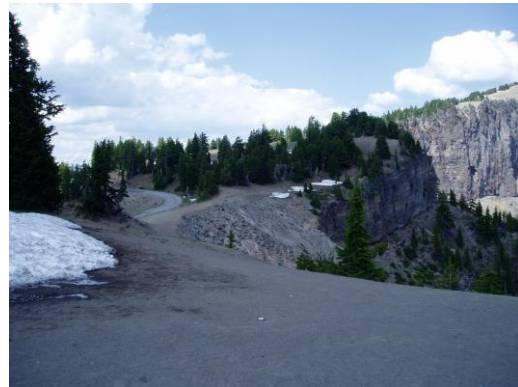
Fig. 70 – Social trail continues up Llaio Rock.

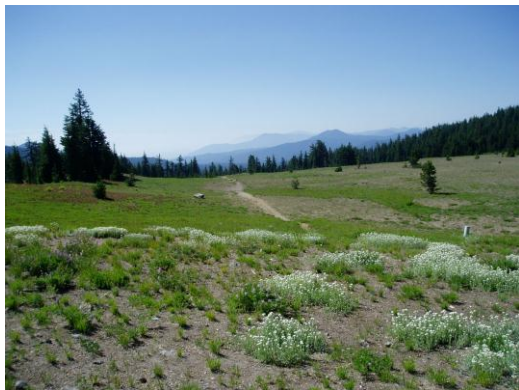
Current Conditions: Wide trail which crosses several deep erosional gullies. Some rusted metal debris and water line stakes with flagging.

Fig. 73 – Trail heading south from Crater Lake Lodge through pumice meadow.

Recommendations: If this is an official trail it should be marked as the Raven Trail. It is unclear from the Lodge if this is really a trail or a social trail to a hang-out spot above Munson Valley Rd. Widening erosional gullies and trampled vegetation are the most pressing issues of this site.

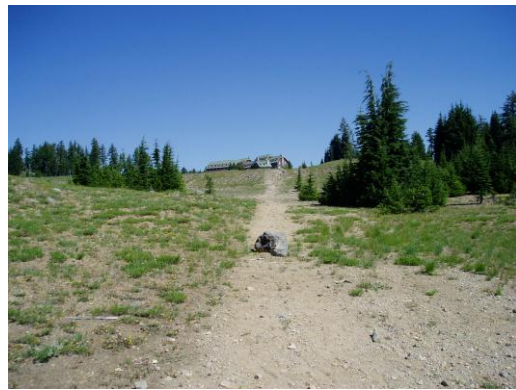
Fig. 74 – Looking back up trail to Lodge.

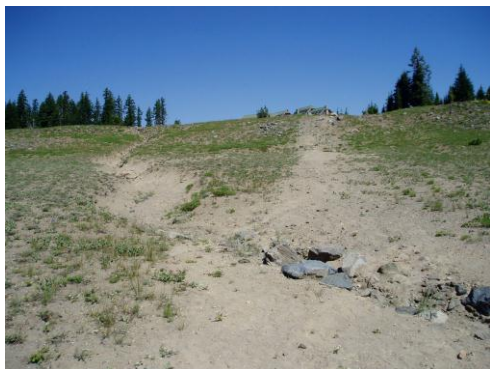
Fig. 75 – Erosional gullies forming parallel to and across the trail.

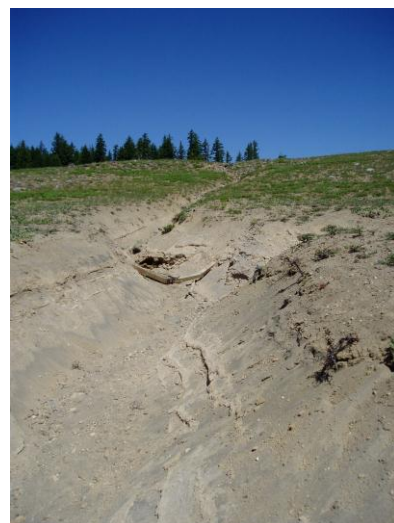
Fig. 76 – Deep erosional gullies forming.

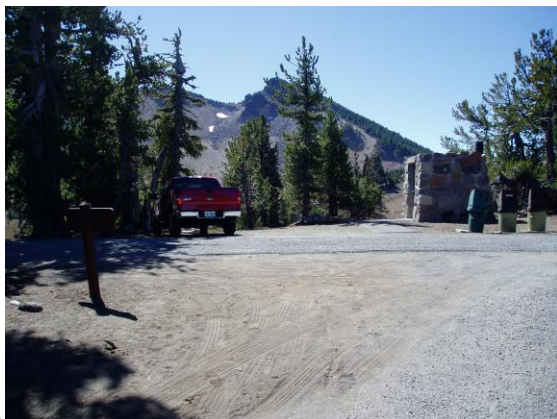
Current Conditions: Parking, traffic flow and a small number of picnic tables (three) is a problem at this site. Unclear parking causes visitors to park chaotically, denuding vegetation and damaging trees and shrubs. As visitors park along the side they block traffic going around the loop road through the area. Vegetation is trampled in between picnic sites and broken pavement and gravel makes the site look neglected.

Fig. 79 – Traffic impacts on vegetation.

Recommendations: This site needs a complete overhaul to improve aesthetics, parking and traffic congestion. More picnic tables are needed to serve the number of visitors wanting to use the site. New paving and designated paved parking spaces for each site would eliminate the chaotic parking and trampling of vegetation (as was done at Vidae Falls Picnic Area). Revegetation of areas where cars currently park, and in between and around picnic sites is needed. This area could also use revegetation of whitebark pine since seedlings have been trampled or driven over.

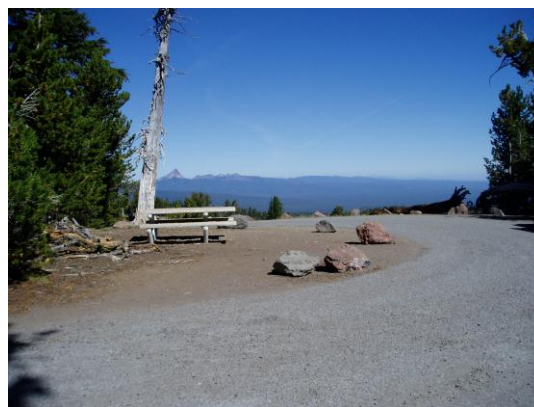
Fig. 80 – Denuded site needs revegetation.

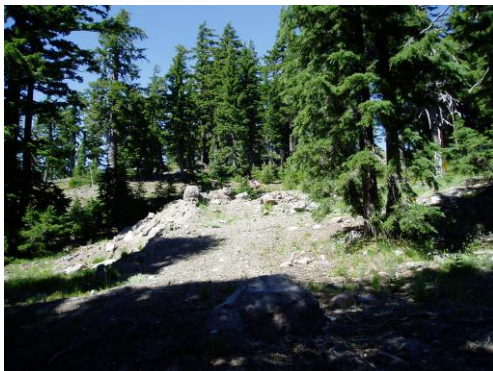
Description: Road cut into forest leads downslope to old leach field. Many rock and tree push piles line the area around the road cut. Large boulders have been placed into drainage. Small rocks and gravel are also piled up in various locations around the site. A large area of pumice with no vegetation and several areas of trees laid over the road cut. Much of the area is devoid of vegetation although there is some natural recruitment of Mt. Hemlock (*Tsuga mertensiana*), Pussy paws (*Calyptidium umbellatum*), *Lupinus sp.* and grass *sp.*

Fig. 81 – Road cut push pile looking back towards Munson Valley Rd.

Recommendation: This site is visible from both Munson Valley road and from Dutton Creek Trail. The road cut was put in without permission to remove an old leach field. This damaged a historic road (Steve Mark, personal communication) so there is a historic component that may be in need of restoration. The erosional gully filled in with boulders is continuing to erode and is the most pressing natural resource issue at the site. Natural revegetation is helping to obscure the site however, some revegetation is needed in areas where no natural recruitment is occurring.

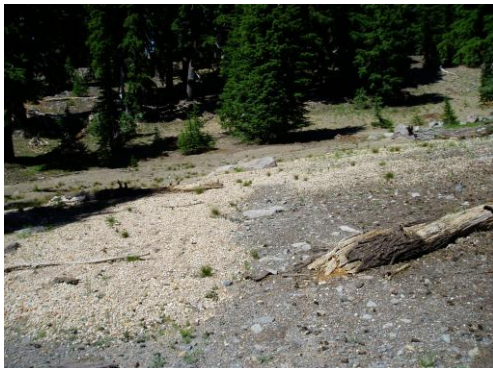
Fig. 83 – Pumice from off-site is spread out over road cut.

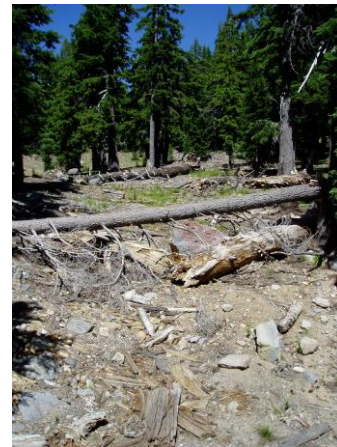
Fig. 84 – Rocks placed in erosional gully.

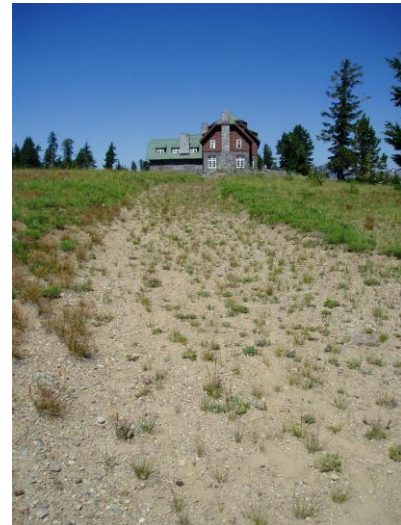
Current Conditions: Obvious road bed about 1 foot below grade. Road is naturally re-vegetating except in eroding areas which appear to be worsening. Some trash debris along the road (broken glass/ceramics, roofing shingles, paper, etc.).

Fig. 91 – Some erosion occurring on steeper grade.

Recommendation: Eroding section should be stabilized. Natural revegetation could be augmented with native seed however this is not a priority site so natural recruitment will do the job.

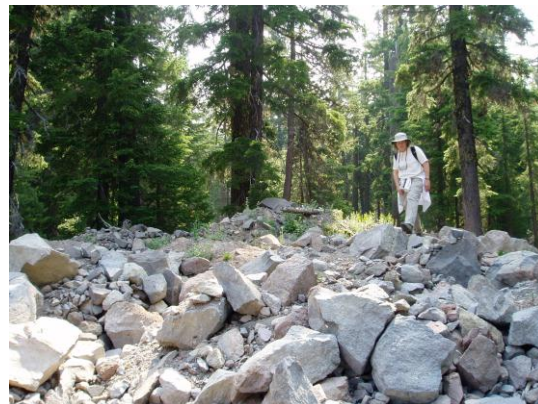
Current Conditions: Rock and gravel piles are naturally revegetating with *Pinus contorta* (Lodgepole pine). Yellow Rocket weed (*Barbarea vulgaris*) was found on the first rock pile to the right as you enter the clearing. The roads crew does continue to use crushed rock from the site.

Fig. 104 – Kathryn Williams investigating rock pile with Yellow Rocket weed (*Barbarea vulgaris*).

Recommendations: This area would be a major restoration project including the removal of some potentially hazardous material (old creosote logs) and the eradication of weeds.

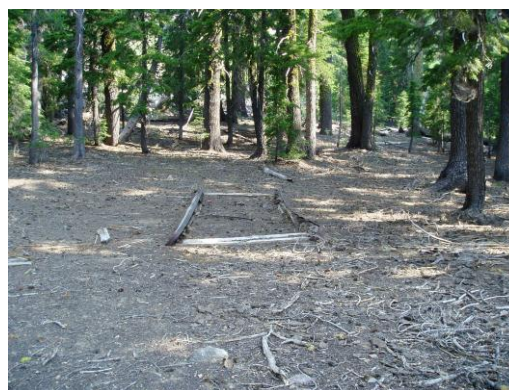
Fig. 106 – Debris in vicinity of rock piles.

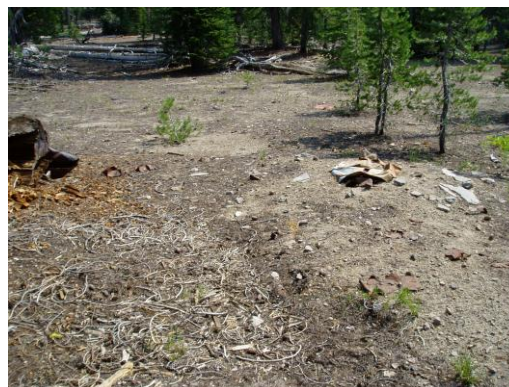
Fig. 108 – Metal barrels and debris at post site.

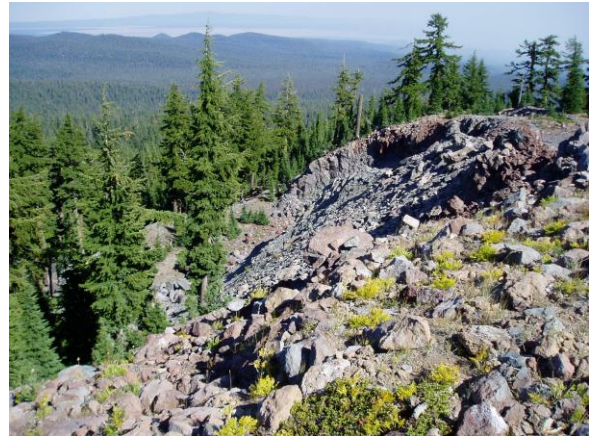
Fig. 110 – Grayback Quarry looking into lower site and cliff face.

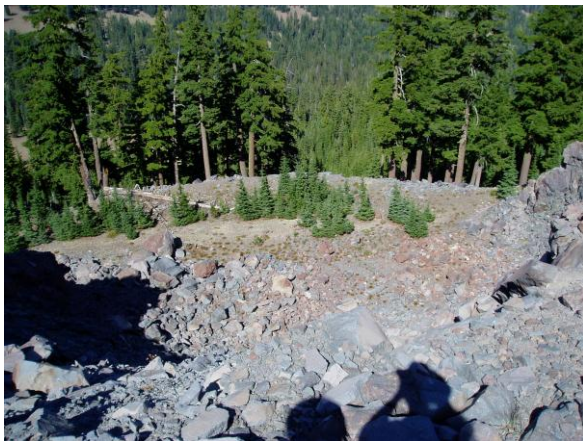
Fig. 111 – Grayback Quarry looking down cliff face into lower site and access road.

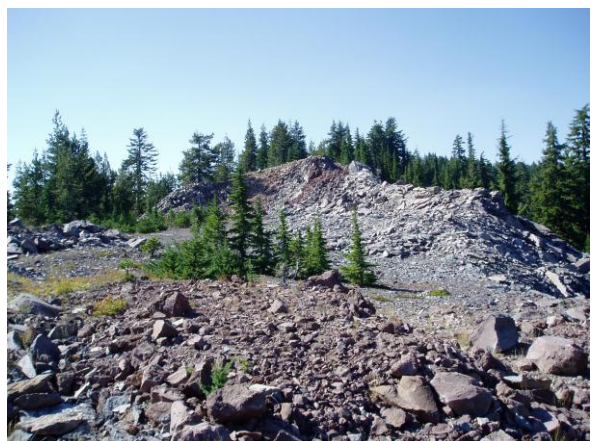
Current Conditions: This quarry is unique because it is one of the few that can be seen from East Rim Road. The area is naturally revegetating with Mt. Hemlock, Shasta red fir, lodgepole pine, pinemat manzanita, *Eriogonum* sp., grasses and sedges.

Fig. 112 – Grayback Quarry upper site with natural revegetation.

Recommendations: This is a very large quarry area and would take significant earth moving to restore the site. Although it can be seen from Rim Drive, the area is naturally revegetating. Recommend allowing mother nature to continue the process.

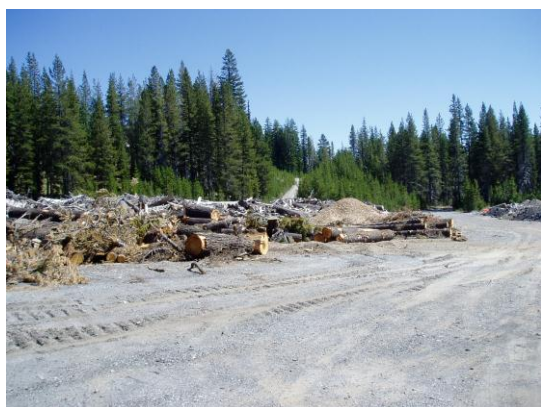
Current Conditions: Dumpsite has a large amount of logs, stumps, rock piles, gravel, asphalt, wood chips and other piles of debris with some trash mixed in. Quarry looked clean except for an old burned out car. No weeds were seen. This is an active site used by the Roads Crew to dispose of all of the above mentioned materials and to use rocks and trees/logs for other projects.

Fig. 113 – Pole Creek Dumpsite tree and log storage with road to quarry in background.

Recommendations: This is a huge site with large impacts from debris and heavy machinery. Since it’s an active site it does not make sense to embark on revegetation.

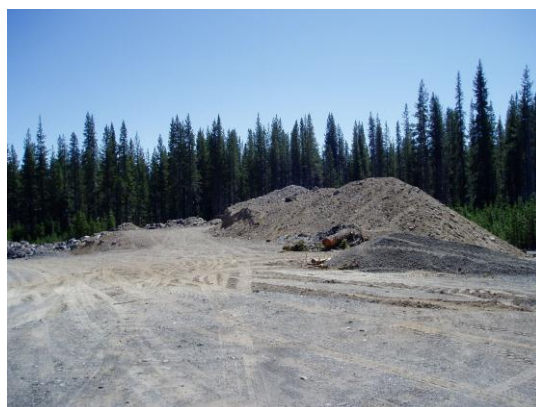
Fig. 114 – Pole Creek Dumpsite gravel and asphalt piles.

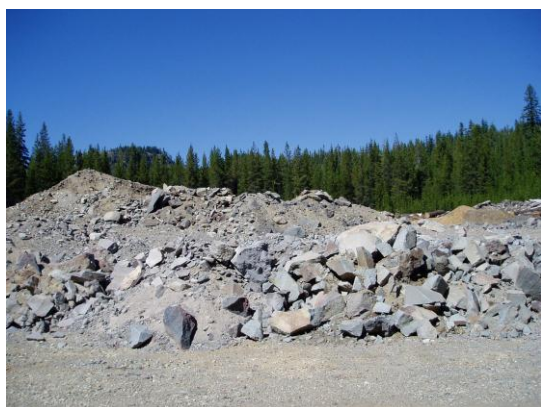
Fig. 115 – Pole Creek Dumpsite rock piles and wood chip pile.

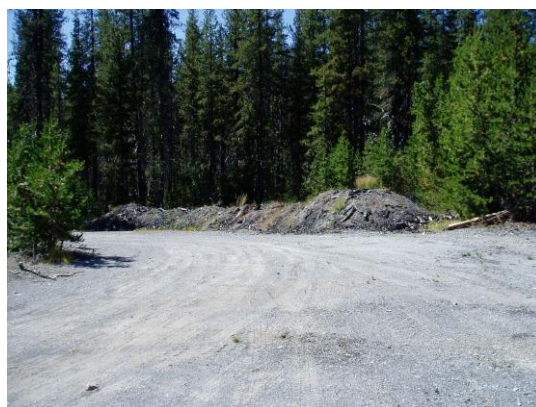
Fig. 116 – Pole Creek Dumpsite asphalt and debris piles.

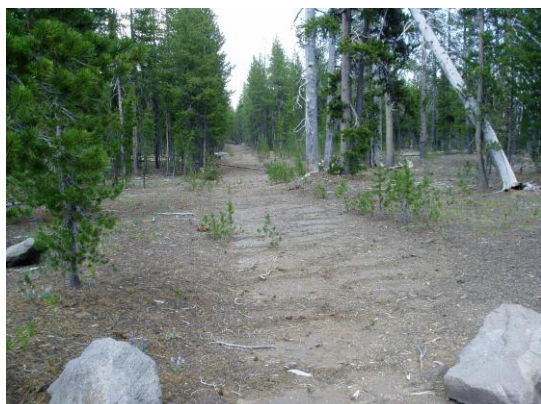
Fig. 117 - Access road from North Entrance Road blocked by boulders.

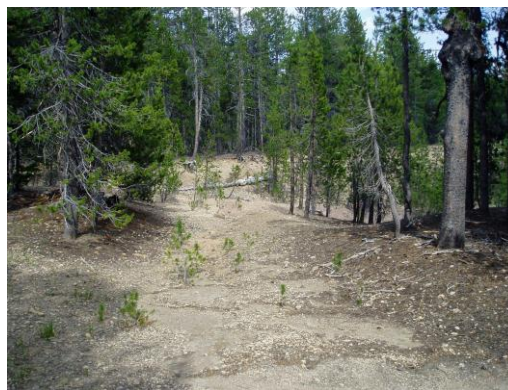
Current Conditions: Side entrance road into pit is eroding but becoming colonized by *Pinus contorta* (lodgpole pine). Lodgpole are colonizing the entire site with some trees as large as 10 feet. No weeds seen.

Fig. 120 - Entrance to borrow pit with *P. contorta* volunteers.

Recommendations: Area is naturally revegetating and is small in scale. Recommend letting this site continue on with natural revegetation.

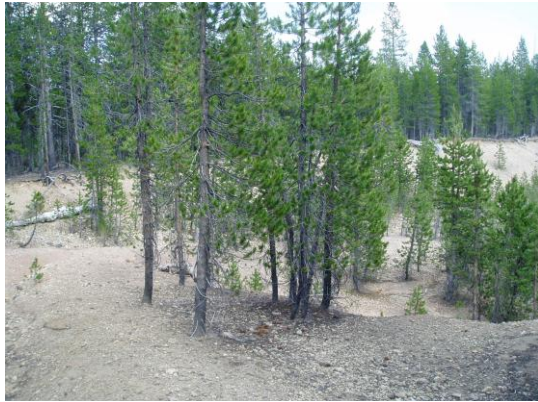
Fig. 121 – Borrow pit with naturally revegetating *P. contorta*.

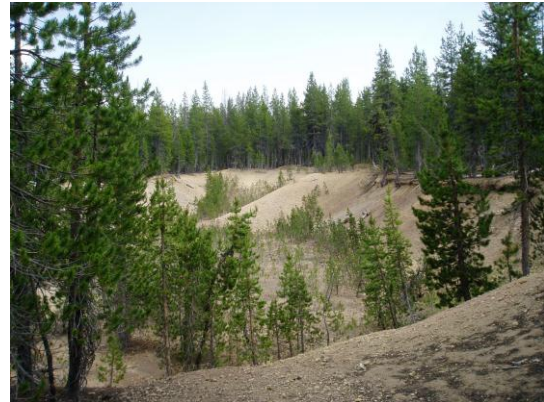
Fig. 122 – Borrow pit with several age classes of *P. contorta* volunteers.

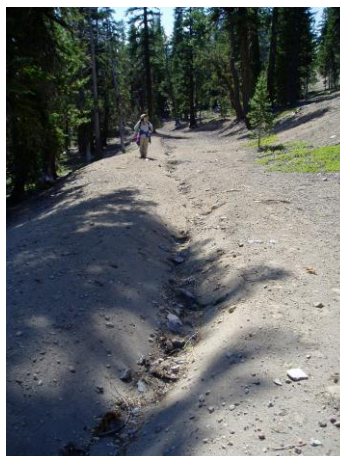
Current Conditions: Road that leads to the site is developing large erosion gully. Piles of different size rocks and rubble surround the perimeter of the quarry. Some lodgepole (*Pinus monticola*), manzanita (*Arctostaphylos nevadensis*), and grass sp. are colonizing the rock piles and gravel/pumice substrate. No weeds were seen at the site.

Fig. 124 –  
Roundtop  
Quarry  
access road  
with  
erosion  
gullies.

Recommendations: This is a very large site, which would take significant earth moving equipment to restore. The most urgent condition is the erosion gully developing along the road bed.

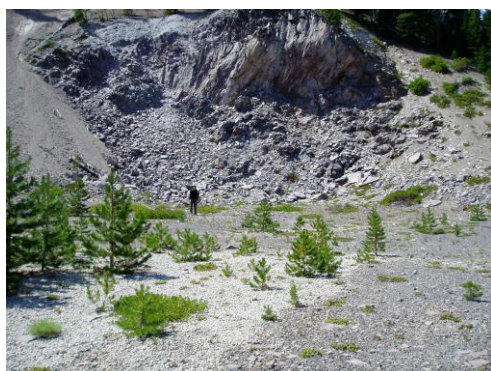
Fig. 125 – Roundtop Quarry with some  
lodgepole and manzanita volunteers.

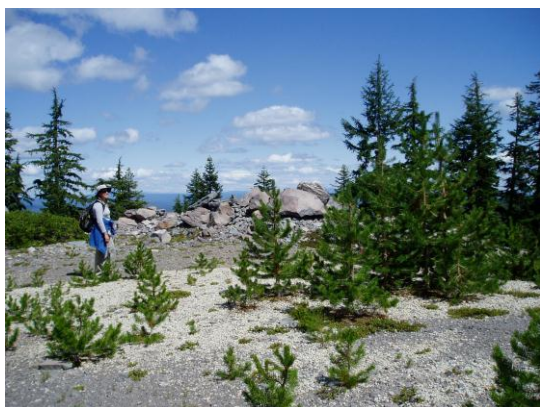
Fig. 127 – Roundtop Quarry pumice and rock piles with lodgepole volunteers.

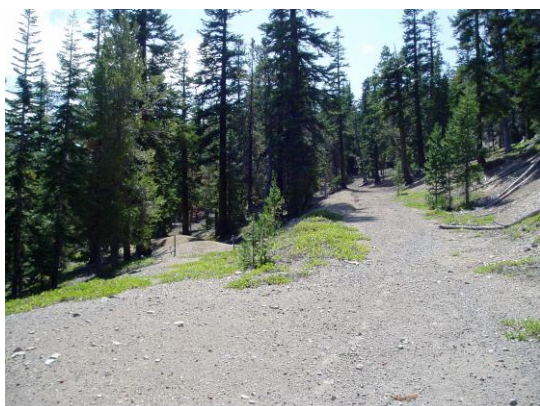
Fig. 129 – Roundtop Quarry access road with pumice piles blocking road on left.

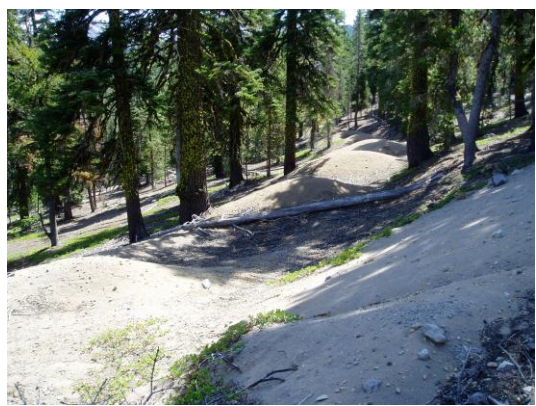
Fig. 130 – Roundtop Quarry access road with pumice piles blocking road.
